# 急傾斜地の崩壊区域調査

様式5-4 危害のおそれのある土地等の座標位置図

II-081K2003

横根5

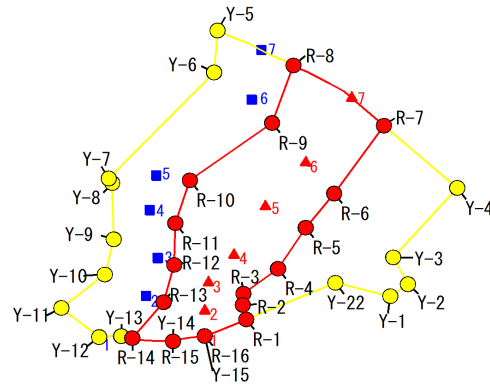
● II-081K2003-b

● II-081K2003-a

危害のおそれのある区域の座標(土砂災害警戒区域)						著しい危険のおそれのある区域の座標(土砂災害特別警戒区域)					
地点記号	X(m)	Y(m)	地点記号	X(m)	Y(m)	地点記号	X(m)	Y(m)	地点記号	X(m)	Y(m)
Y-1	-27795.425	80935.991				R-1	-27800.452	80906.230			
Y-2	-27792.787	80939.581				R-2	-27797.316	80905.512			
Y-3	-27787.080	80936.599				R-3	-27794.870	80905.633			
Y-4	-27772.144	80949.824				R-4	-27789.368	80912.670			
Y-5	-27738.291	80900.309				R-5	-27780.707	80918.515			
Y-6	-27747.365	80899.586				R-6	-27773.358	80924.411			
Y-7	-27770.049	80877.784				R-7	-27758.757	80934.676			
Y-8	-27771.096	80878.543				R-8	-27745.705	80915.811			
Y-9	-27783.197	80878.866				R-9	-27758.181	80911.578			
Y-10	-27790.760	80877.016				R-10	-27770.523	80894.601			
Y-11	-27797.960	80868.054				R-11	-27779.734	80891.592			
Y-12	-27804.220	80875.856				R-12	-27788.687	80891.361			
Y-13	-27804.018	80880.415				R-13	-27796.713	80889.170			
Y-14	-27805.129	80891.115				R-14	-27804.448	80882.691
