急傾斜地の崩壊区域調査

様式5-4 危害のおそれのある土地等の座標位置図

II-1585

根古名2

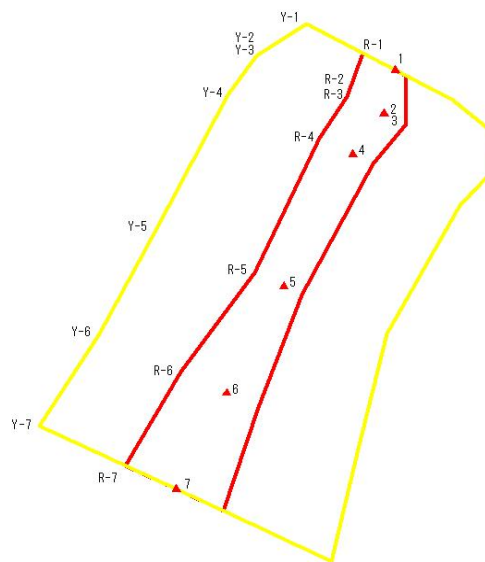
scale:1/1000

急傾斜地の位置		箇所番号	II-1585	箇所名	根古名2	所在地	千葉県富里市根古名宮前				
地点記号	X(m)	Y(m)	地点記号	X(m)	Y(m)	地点記号	X(m)	Y(m)	地点記号	X(m)	Y(m)
Y-1	-28760.432	47628.341	R-1	-28764.655	47636.143						
Y-2	-28765.022	47621.595	R-2	-28770.942	47633.996						
Y-3	-28765.022	47621.595	R-3	-28770.942	47633.996						
Y-4	-28770.619	47617.584	R-4	-28776.905	47630.225						
Y-5	-28789.803	47607.826	R-5	-28796.225	47621.279						
Y-6	-28804.977	47599.881	R-6	-28810.394	47611.093						
Y-7	-28818.141	47591.667	R-7	-28823.877	47603.514
