急傾斜地の崩壊区域調書

様式5-1 危害のおそれのある土地等の座標位置図(1/2)

急傾斜地の位置	箇所番号	I-1050	箇所名	洲宮1	所在地	千葉県館山市洲宮大作
---------	------	--------	-----	-----	-----	------------

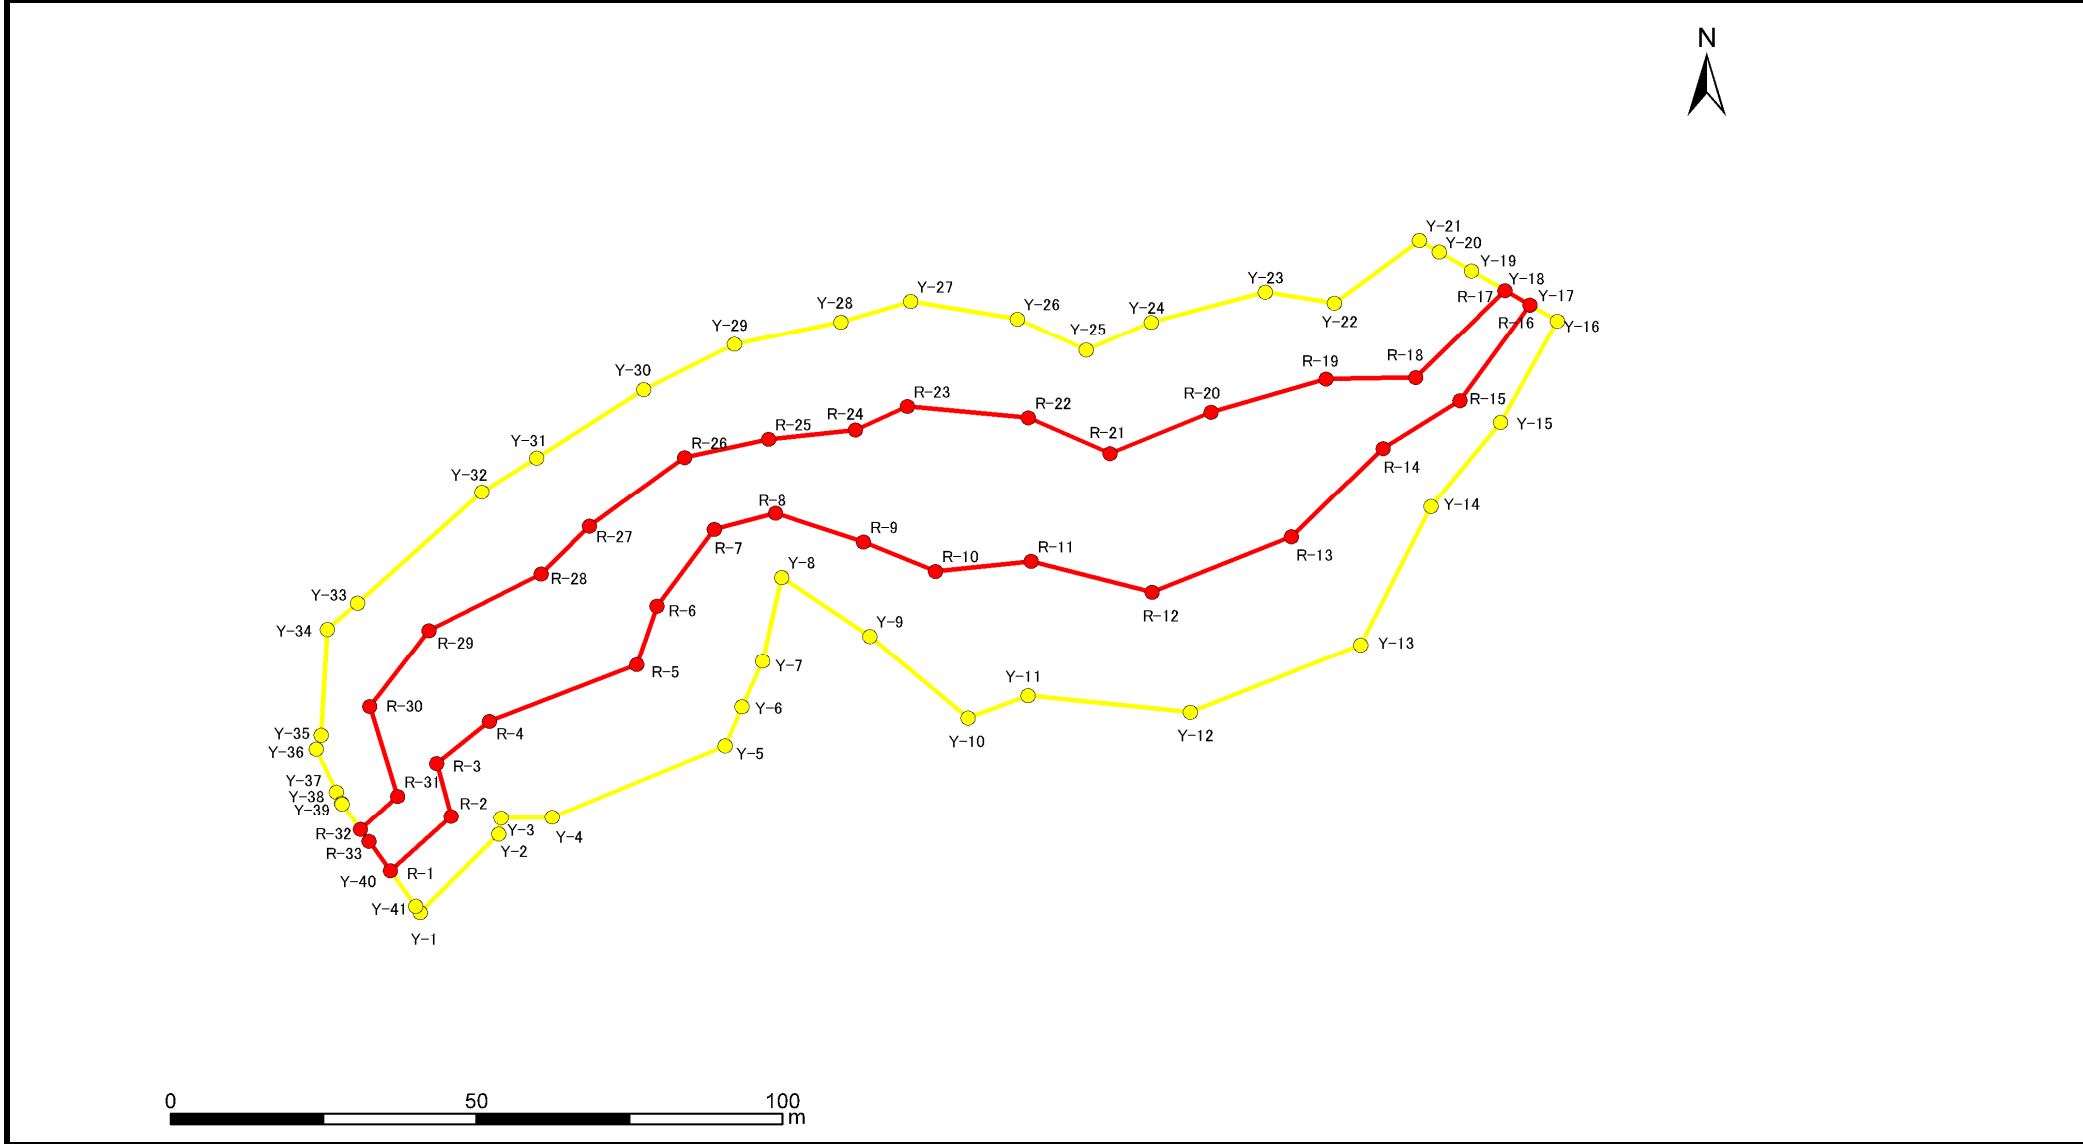
危害のおそれのある土地の区域の座標(土砂災害警戒区域)

地点記号	X(m)	Y(m)	地点記号	X(m)	Y(m)	地点記号	X(m)	Y(m)	地点記号	X(m)	Y(m)
Y-1	459.85	-116220.48	Y-36	442.77	-116192.86						
Y-2	472.70	-116207.21	Y-37	446.08	-116200.08						
Y-3	473.10	-116204.45	Y-38	446.94	-116201.95						
Y-4	481.52	-116204.34	Y-39	447.02	-116202.12						
Y-5	509.90	-116192.29	Y-40	451.46	-116208.48						
Y-6	512.70	-116185.71	Y-41	459.08	-116219.39						
Y-7	516.05	-116177.98									
Y-8	519.18	-116163.88									
Y-9	533.66	-116173.78									
Y-10	549.79	-116187.62									
Y-11	559.68	-116183.82									
Y-12	586.33	-116186.63									
Y-13	614.26	-116175.20									
Y-14	625.82	-116151.96									
Y-15	637.26	-116137.76									
Y-16	646.57	-116120.60									
Y-17	642.09	-116117.91									
Y-18	638.00	-116115.46									
Y-19	632.51	-116112.16									
Y-20	627.19	-116108.97									
Y-21	623.94	-116107.02									
Y-22	609.99	-116117.58									
Y-23	598.61	-116115.71									
Y-24	579.90	-116120.82

Y-25	569.20	-116125.56									
Y-26	557.92	-116120.25									
Y-27	540.39	-116117.29									
Y-28	528.93	-116120.78									
Y-29	511.45	-116124.56									
Y-30	496.57	-116132.22									
Y-31	478.96	-116143.77									
Y-32	469.95	-116149.57									
Y-33	449.56	-116168.18									
Y-34	444.60	-116172.59									
Y-35	443.58	-116190.51
